**DEPARTMENT OF TRANSPORTATION**

Contract #: 04-0120F4Cty: SF/ALA Rte: 80 PM: 13.2/13.9File #: 69.28**WELDING INSPECTION REPORT****Resident Engineer:**Siegenthaler, Peter**Address:** 333 Burma Road**City:** Oakland, CA 94607**Report No:** WIR-018099**Date Inspected:** 08-Nov-2010**Project Name:** SAS Superstructure**OSM Arrival Time:** 700**Prime Contractor:** American Bridge/Fluor Enterprises, a JV**OSM Departure Time:** 1900**Contractor:** Zhenhua Port Machinery Company, Ltd (ZPMC), Changxing Island **Location:** Shanghai, China**CWI Name:** Xu Le Feng**CWI Present:** Yes No**Inspected CWI report:** Yes No N/A**Rod Oven in Use:** Yes No N/A**Electrode to specification:** Yes No N/A**Weld Procedures Followed:** Yes No N/A**Qualified Welders:** Yes No N/A**Verified Joint Fit-up:** Yes No N/A**Approved Drawings:** Yes No N/A**Approved WPS:** Yes No N/A**Delayed / Cancelled:** Yes No N/A**Bridge No:** 34-0006**Component:** TOWER Components**Summary of Items Observed:**

**TOWER JETTY**

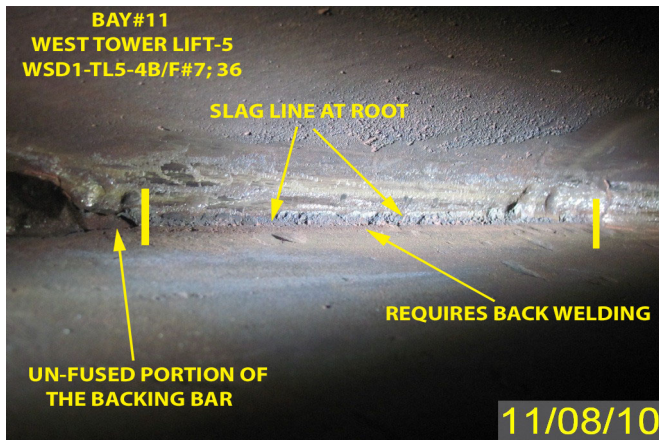
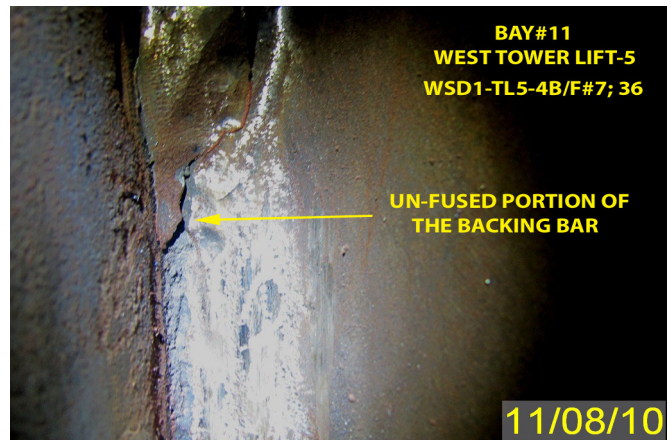
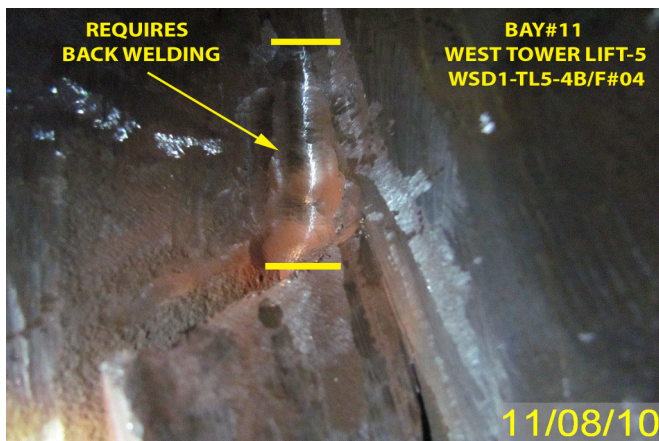
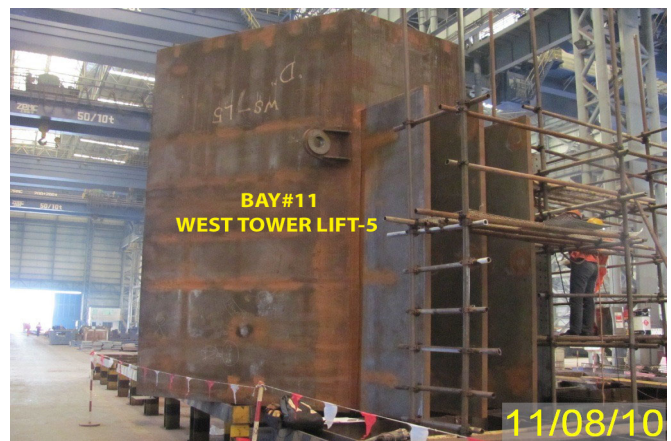
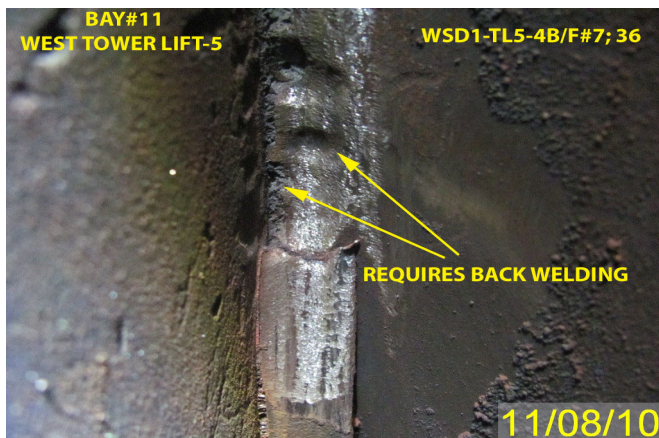
During the Caltrans Quality Assurance (QA) in-process observation on West Tower Lift-5 grillage, this QA Inspector discovered the following issue:

- ZPMC offered NWIT #007275 for Visual Testing (VT) and Magnetic Particle Testing (MT) of a repair to an area of backing bar non-fusion.

- 1) WSD1-TL5-4B/F#07; 36 – Un-fused backing bar has not been completely removed. There is a slag line at the entire visible root pass area.

- 2) WSD1-TL5-4B/F#04 – Root pass has been ground out to an average depth of 1.5mm. Back welding has not been performed.

- Welds are T-Joint Complete Joint Penetration (CJP) welds.

To close the Non-Conformance Report, NCR#ZPMC-0839, ZPMC had submitted the Notice of Witness Inspection Number (NWIT) # 007275. This repaired area has been previously tested and accepted by ZPMC Quality Control (QC) personnel. ZPMC's QC personnel performed 100% VT and MT inspection of this area.

AWS D1.5 2002, Section 3.13.2: “Groove welds made with the use of steel backing shall have the weld metal

thoroughly fused with the backing.”

AWS D1.5 2002, Section 4.6.9: “CJP groove welds made without the use of steel backing shall have the root gouged to sound metal before welding is started from the second side.”
